# An Evaluation of Flashing Crosswalks in Gainesville and Lakeland

**Herman Huang**  
**University of North Carolina at Chapel Hill**  
**Highway Safety Research Center**

***Florida Department of Transportation***  
**November 2000**

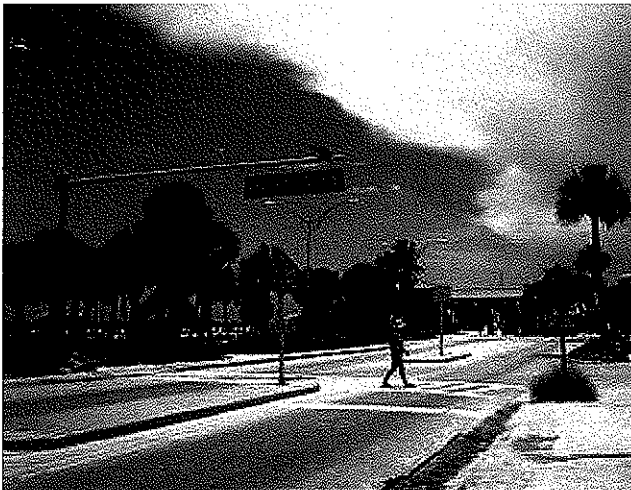
To enhance visibility at midblock crosswalks, cities may use high-visibility (continental) crosswalk markings, or they may install supplementary signs and devices. For example, Clearwater, Florida, uses an internally-illuminated overhead sign (Figure 1). Portland, Oregon, and several cities in New York State are experimenting with a **YIELD TO PEDESTRIANS** sign that is mounted on a traffic cone placed at the crosswalk, on the centerline of the roadway (Figure 2).

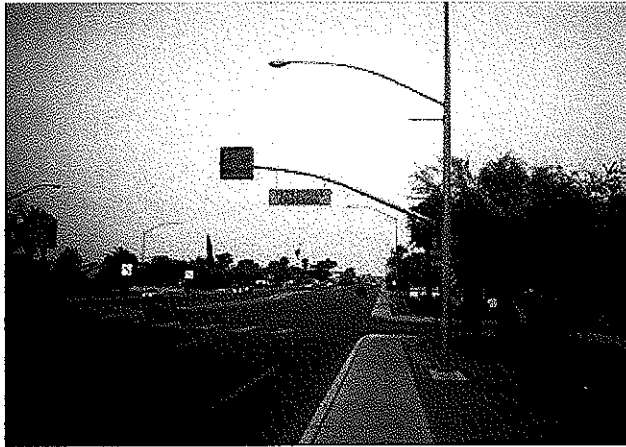
Tucson, Arizona, has several pedestrian-activated overhead LED signs (STOP FOR PEDESTRIANS IN CROSSWALK) (Figure 3). Some of these are being replaced by pedestrian-activated "fire truck" signals that first display a flashing amber signal that warns drivers to be prepared to stop. This is followed immediately by an alternating red signal requiring that drivers stop. Toronto, Ontario, Canada has hundreds of internally-illuminated overhead signs and beacons that flash when activated, as illustrated in Figure 4.

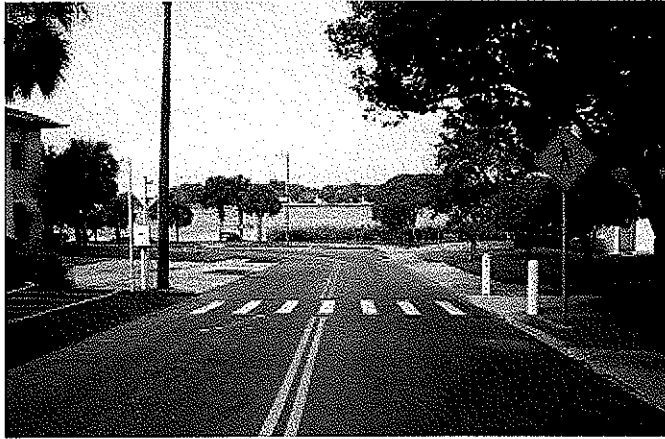
The crosswalk connects single-family houses to the north with Florida Presbyterian Homes (a senior citizens' home) to the south (Figure 6). Many senior citizens live in the houses and go to the seniors' home for meals and social activities. In-pavement flashers were added to the existing crosswalk at this location in July 1999 (Figure 7). Pedestrians activate the flashers by stepping in between bollards on the north side and by entering the microwave detection zone on the south side (Figures 8 and 9). Pedestrian activity is very light except when meals and social events are scheduled in the seniors' home.

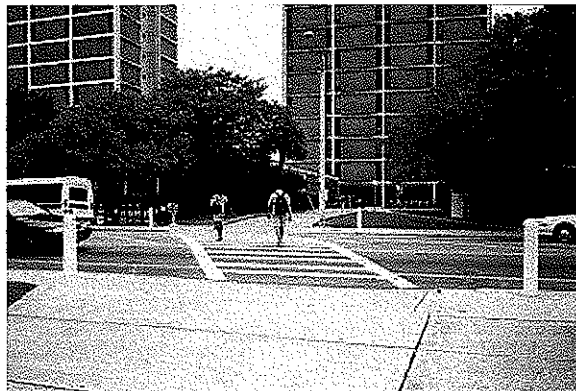
Gainesville B Museum Road, just west of SW 13<sup>th</sup> Street

Museum Road is an east-west road with two through lanes, a painted median, and bike lanes on both sides. It is one of the main thoroughfares on the University of Florida campus. The speed limit is 20 mi/h (32 km/h) and the ADT is 14,500 vehicles per day. The in-pavement flashers were added to the existing crosswalk in August 1999. Pedestrians activate the flashers by walking in between bollards. There are also speed humps about 40 feet (12 m) upstream of the crosswalk in each direction. Pedestrian activity is steady and sometimes heavy during weekdays, when classes are in session.

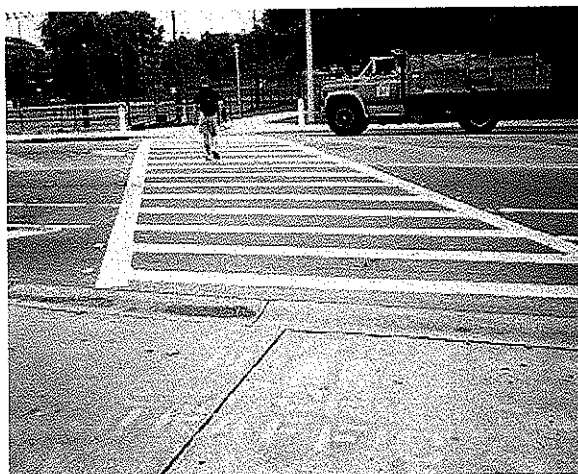
pedestrians using the crosswalk, so that they would benefit from motorists yielding to them (Figure 16).

The chi-square statistic was used to compare the percentages of pedestrians who crossed in the crosswalk. The vast majority of pedestrians at both locations crossed within the crosswalk (Figure 17 and Tables A-7 and A-8). The slight decrease in Gainesville was statistically significant (chi-square statistic = 3.23, p-value = 0.072) but is probably not of *practical* significance for two reasons. First, even with the decline, 95.0 percent of pedestrians still used the crosswalk. At such high levels of crosswalk usage, there is not much room for improvement. Second, the chi-square statistic becomes more sensitive to small percentage differences when the sample sizes increase. The improvement in Lakeland was also significant (chi-square statistic = 11.050, p-value < 0.001).

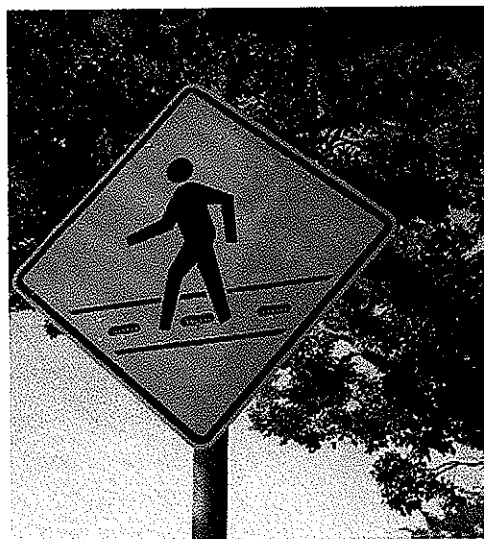
7. The flashers should be examined periodically for signs of wear and tear. They can be situated on the roadway so that they are not in the direct path of vehicle tires. The flashers should be placed so that they do not impede bicyclists.
8. This study was an evaluation of flashing crosswalks at two locations. Evaluations of more flashing crosswalk installations in Florida and other states are needed to better understand their effects on driver and pedestrian behavior in different situations. A longer-term and more comprehensive study would include an analysis of the effects of flashing crosswalks on motor vehicle - pedestrian crashes after an adequate sample of such treatment sites exists.
